# ESTLING LAKE DAM

NJ DEP Dam #25-169

NJ Transit & Estling Lake Corporation

## 2021 Regular Dam Inspection

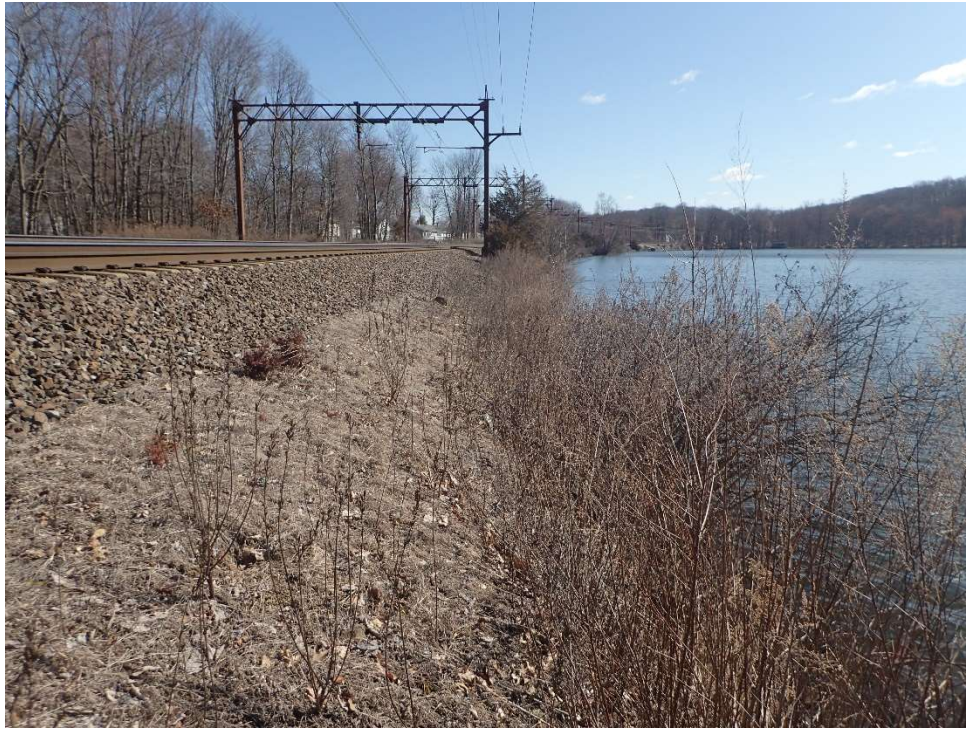
Trees, Undesirable Growth or Debris, Animal Burrows: **Small Trees, Underbrush, throughout the full length of the upstream slope (See Photos 1 & 2). No animal burrows noted.**

PHOTO 1: View of Estling Lake Dam reservoir looking northeast.

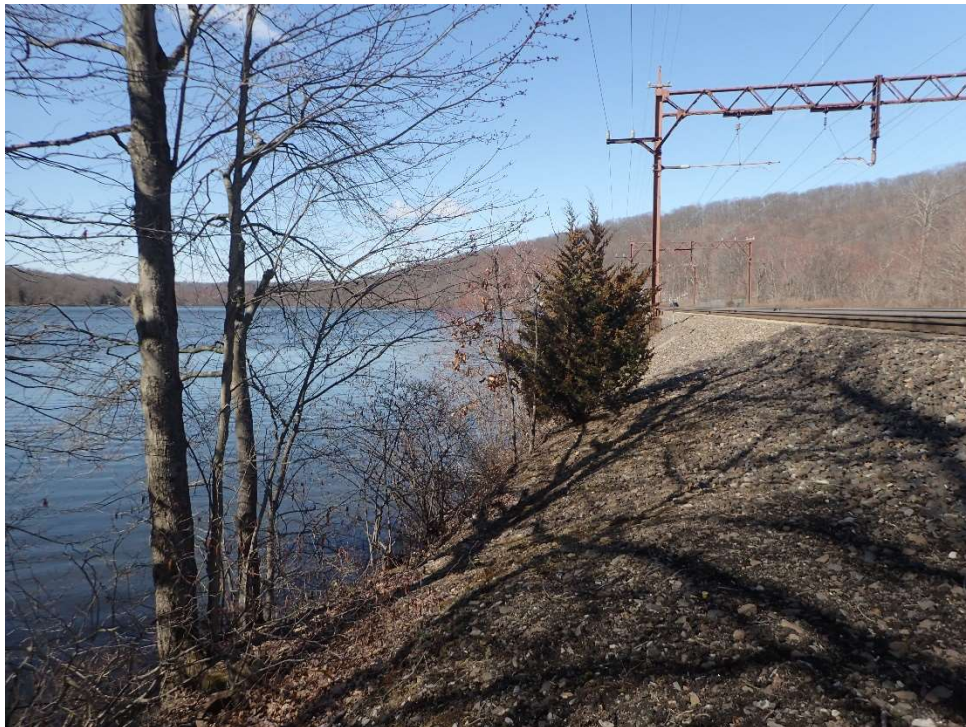
PHOTO 2: View of Estling Lake Dam reservoir looking southwest.

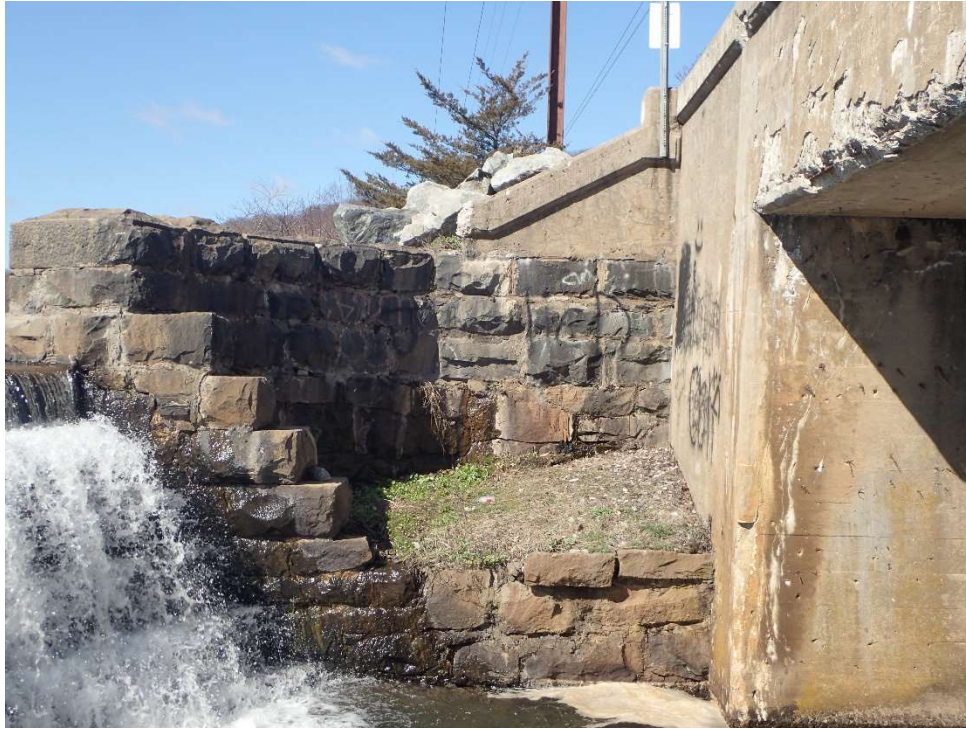
PHOTO 3: Junction of west spillway wingwall with concrete bridge and wingwall looking southwest.

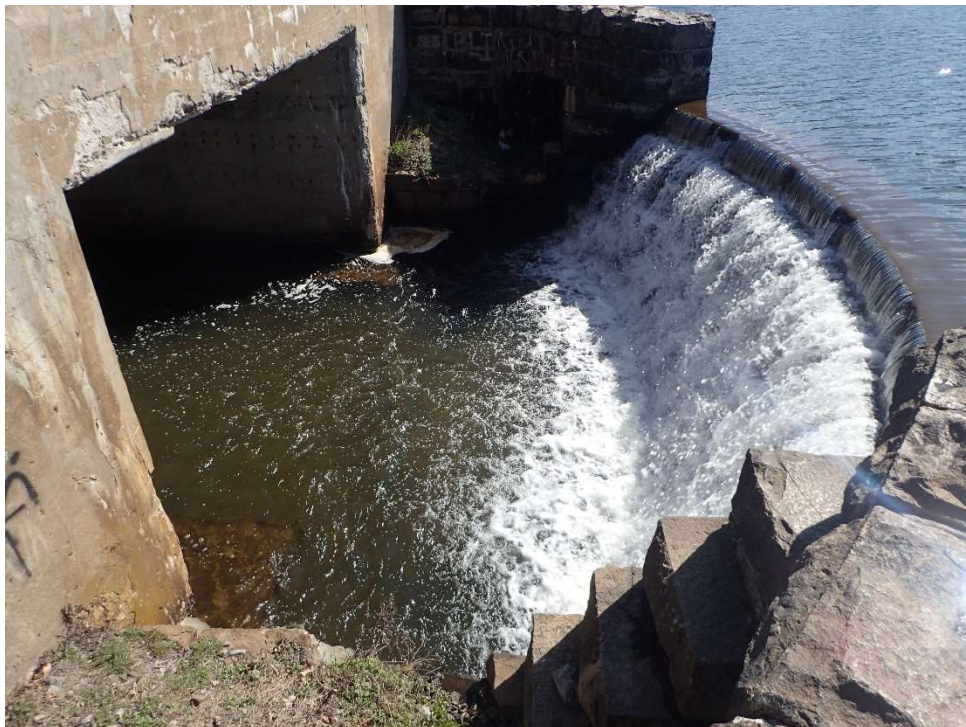
PHOTO 4: Upstream face of Dam including face of concrete bridge looking southeast.

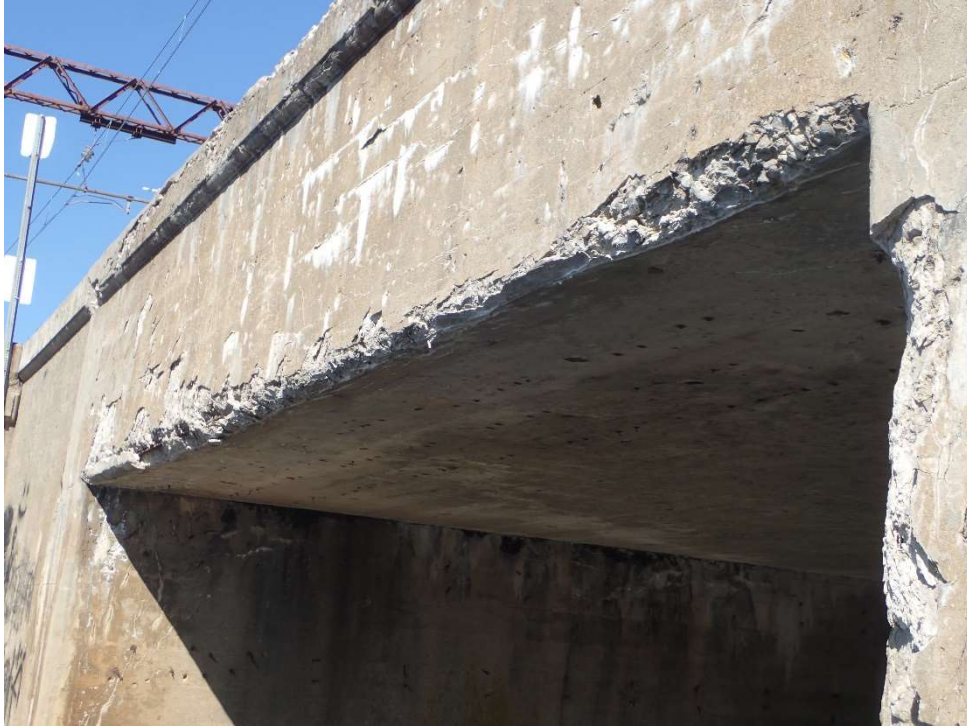
**Upstream – Spalling, cracking, and efflorescence is present on upstream bridge face and parapet with exposed reinforcement (See Photo 5). Efflorescence, minor staining and scaling is visible to the interior faces. Minor seepage on interior faces.**

PHOTO 5: Close up of upstream bridge deterioration with spalls and exposed reinforcement looking northwest.

**Address bridge repairs as required by the NBIS inspection. Continue execution of previous studies and recommendations, already underway, i.e. vegetation removal and control.**

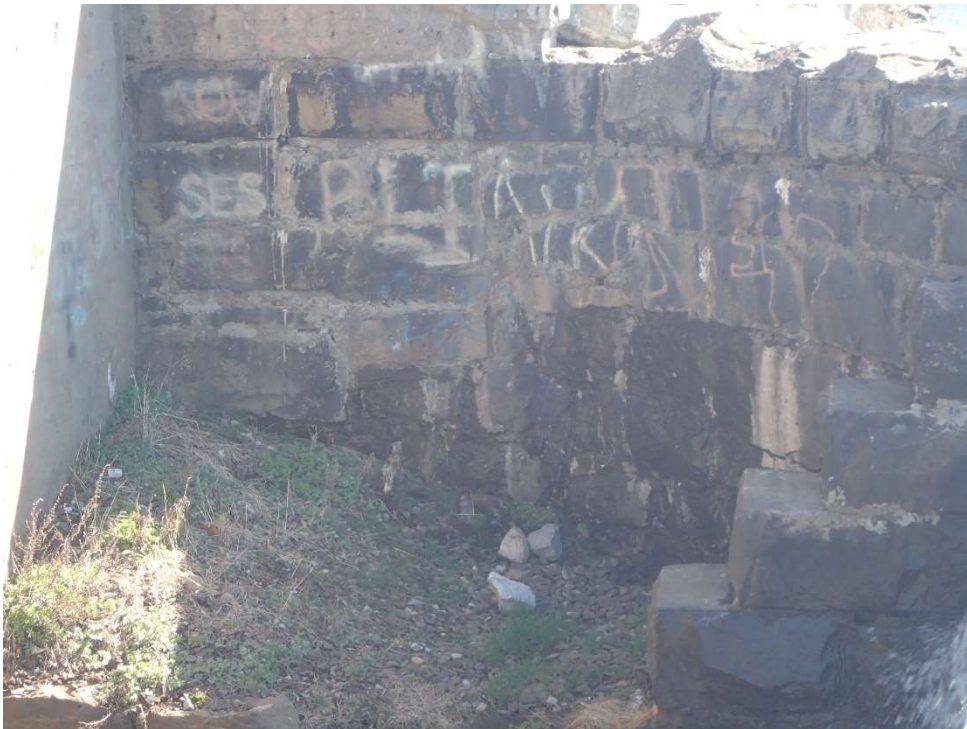
Joints: **Some visible seepage observed (See Photos 6 & 7).**

PHOTO 6: Joint deterioration and seepage at eastern spillway wingwall looking northeast.

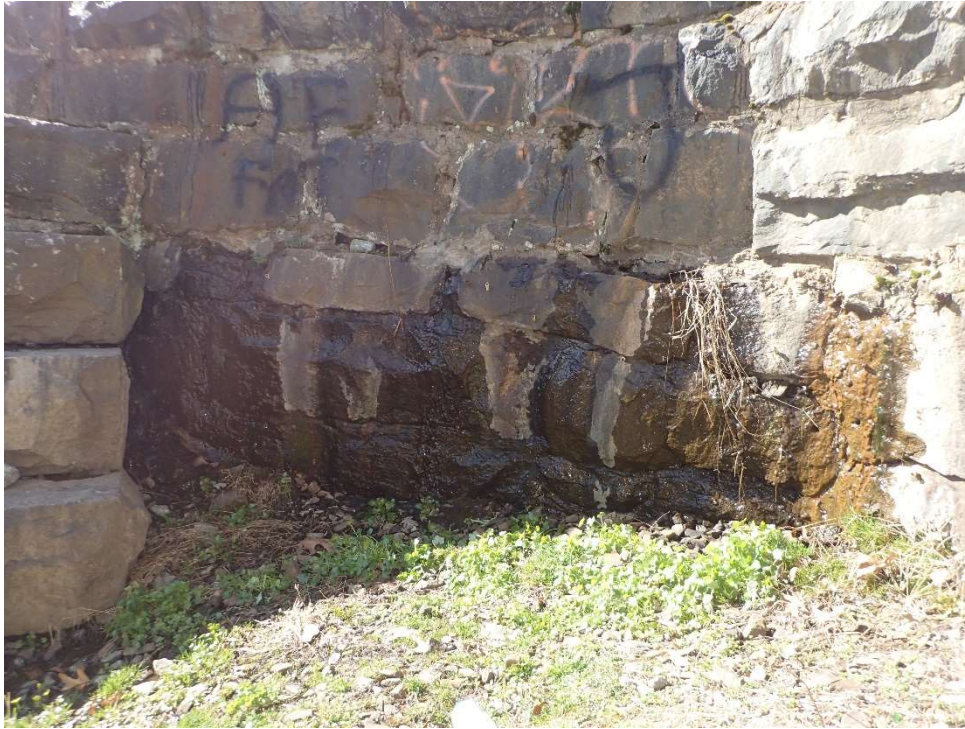
PHOTO 7: Joint deterioration and seepage at western spillway wingwall looking west.

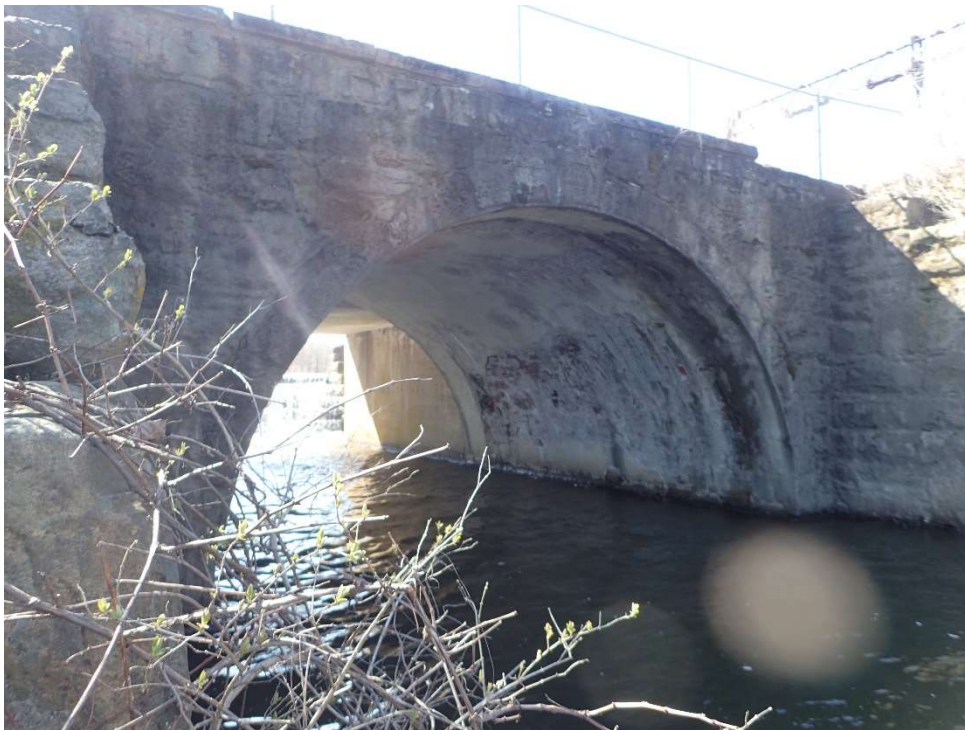
Unusual Conditions: **Reinforced concrete bridge and wingwalls constructed over masonry spillway wingwalls when concrete bridge added to masonry bridge (See Photo 8).**

PHOTO 8: Downstream face of masonry bridge looking southwest.

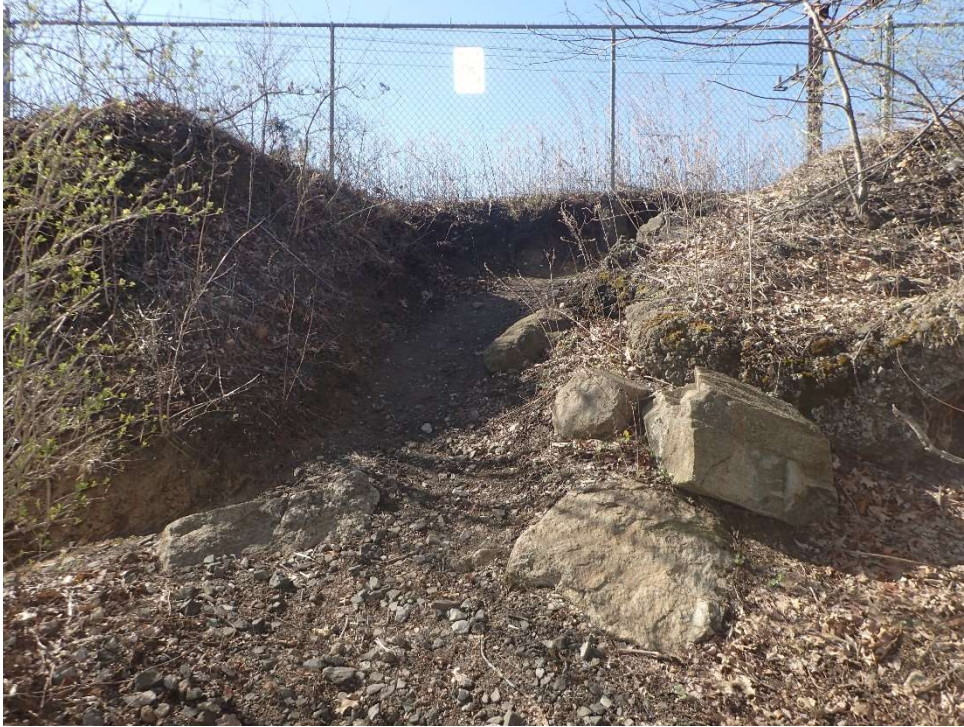
Unusual Conditions: **Footpath worn into downstream face west of bridge (See Photo 9).  
One animal burrow located. Small burrow found to the west of the outlet (See Photo 11).**

PHOTO 9: Eroded footpath along masonry bridge at northwest embankment looking south.

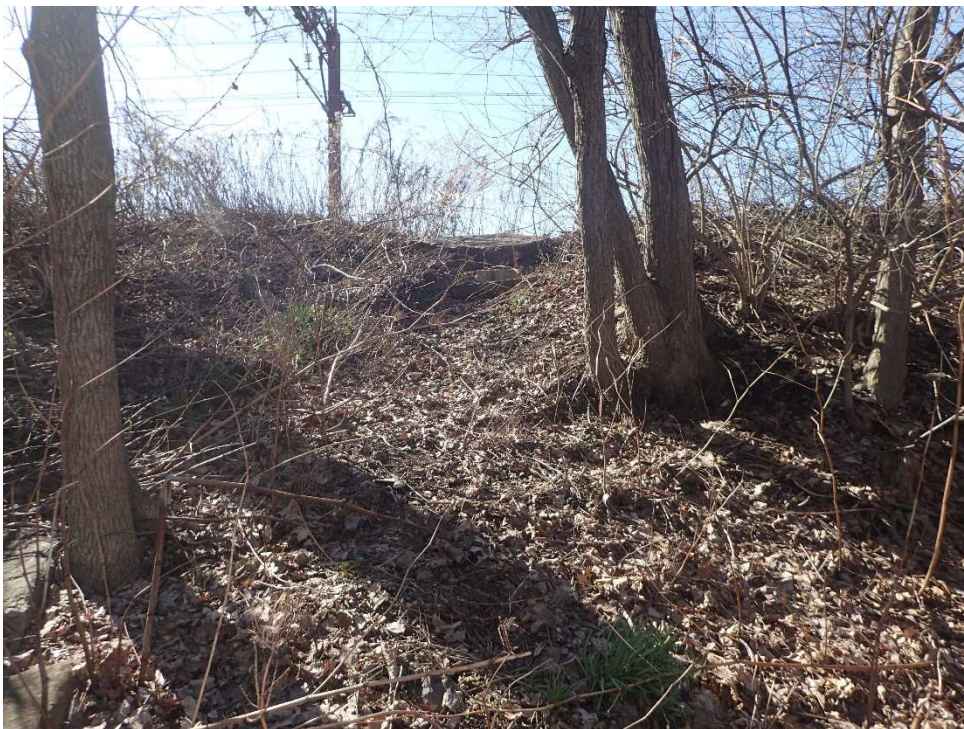
PHOTO 10: Minor surface erosion along footpath looking south.

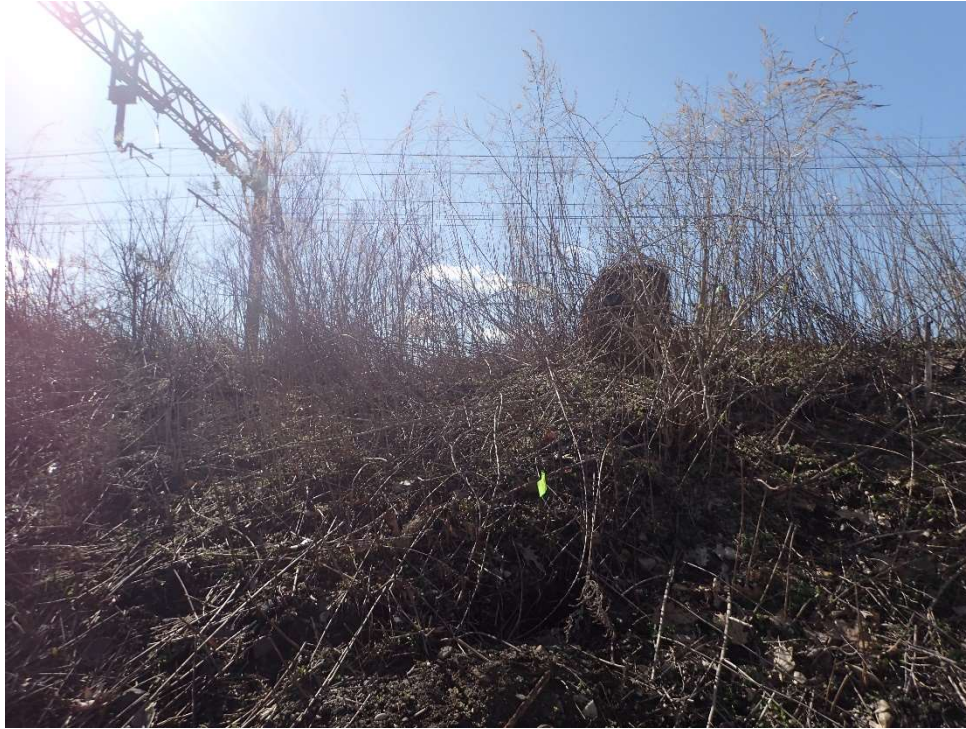
PHOTO 11: Small animal burrow on downstream embankment, approximately 3" looking southeast.

We recommend addressing the animal borrow found in the downstream embankment. See photo location exhibit Downstream Embankment section in checklist. Continue to execute the Vegetation Management Plan to remove undesirable growth on the embankment. Previous short-term recommendations have been addressed. Dam studies are ongoing and vegetation management plan is being executed. Significant heavy vegetation has been removed from portions of the downstream and upstream embankment. Long term studies (Hydrology & Hydraulics, Embankment Stability Analysis) have been performed and submitted to NJDEP. Probable Maximum Flood analysis is underway and anticipated to be completed in April 2020.

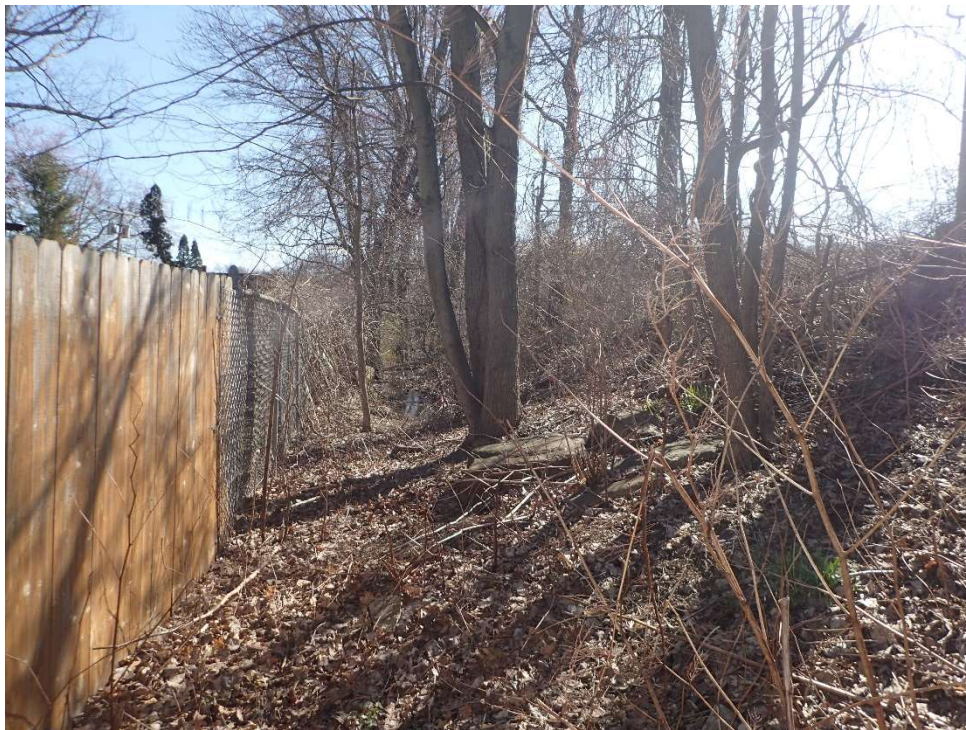
PHOTO 12: Downstream embankment with full-grown trees looking northeast.

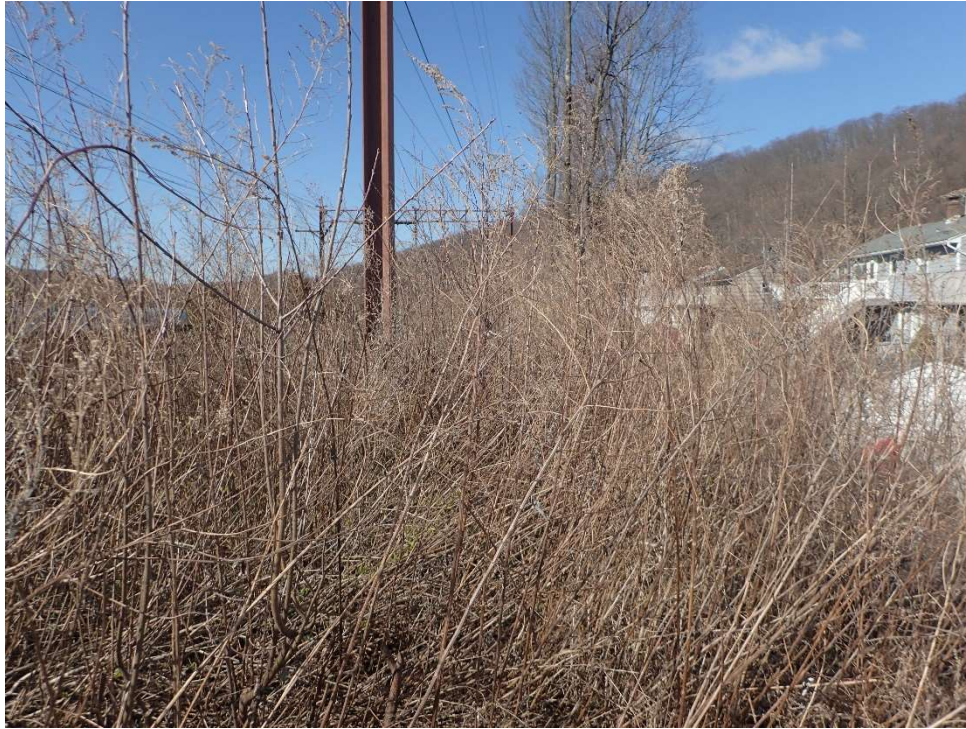
PHOTO 13: Previous area of clearing with excessive vegetation growth along downstream embankment looking southwest.

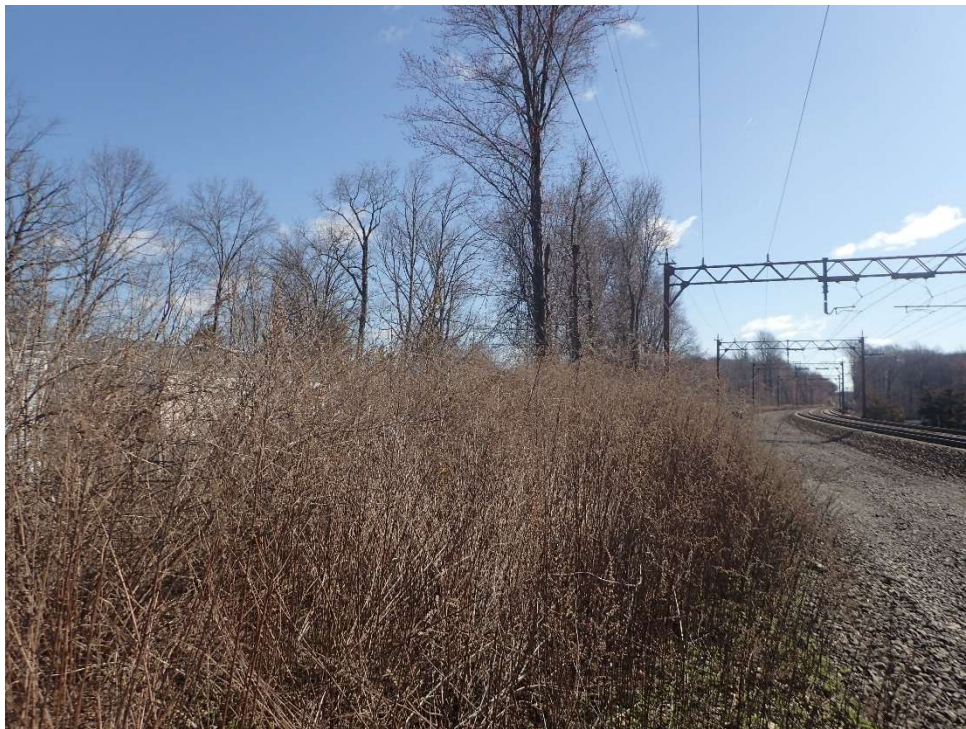
PHOTO 14: Previous area of clearing with excessive vegetation growth along downstream embankment looking northeast.

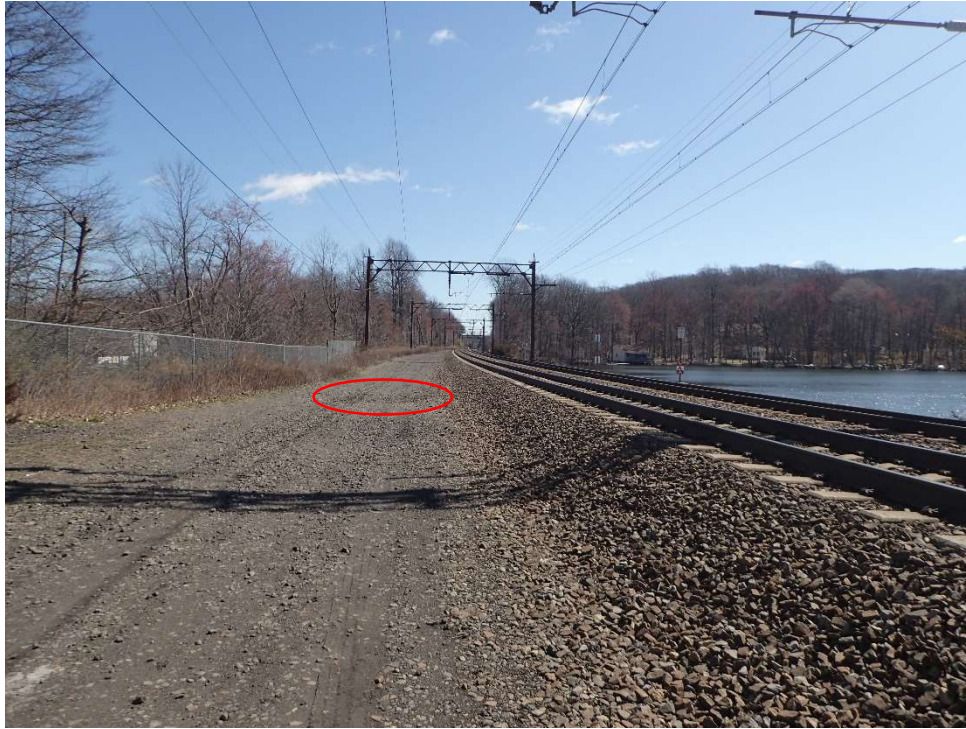
Settlement: **There are regular dips (~ every 40 to 60 ft) in the surface allowing ponding to occur (See Photo 15). This condition exists along the empty site of the rail embankment well beyond the limits of the dam embankment and throughout the railway corridor.**

PHOTO 15: Concave surface on crest of dam looking northeast.

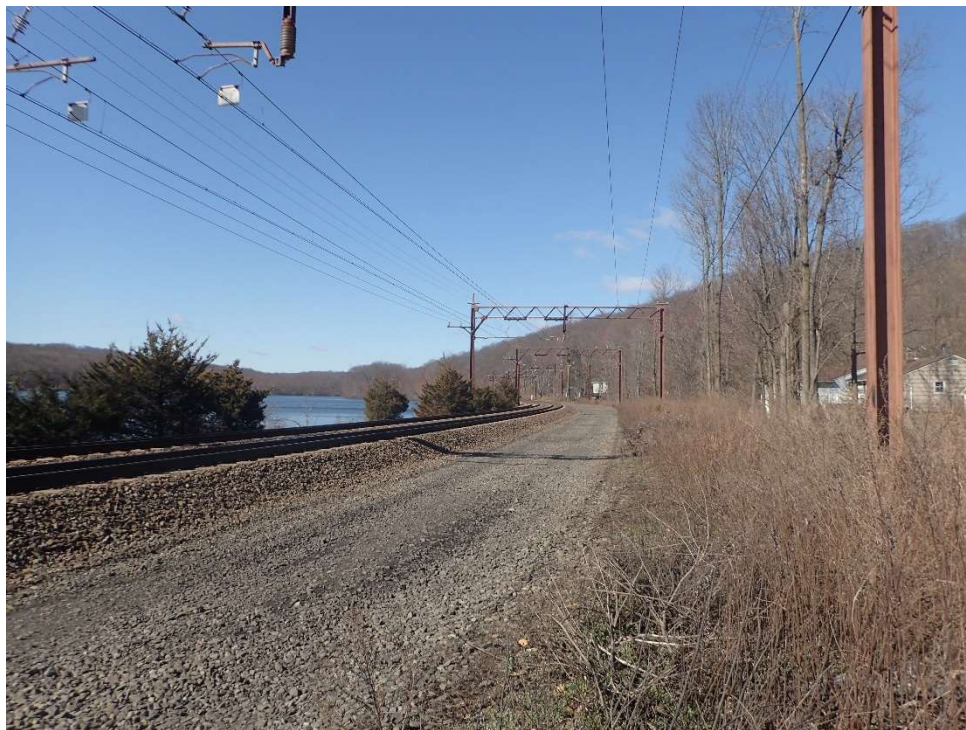
PHOTO 16: Crest of dam looking southwest.

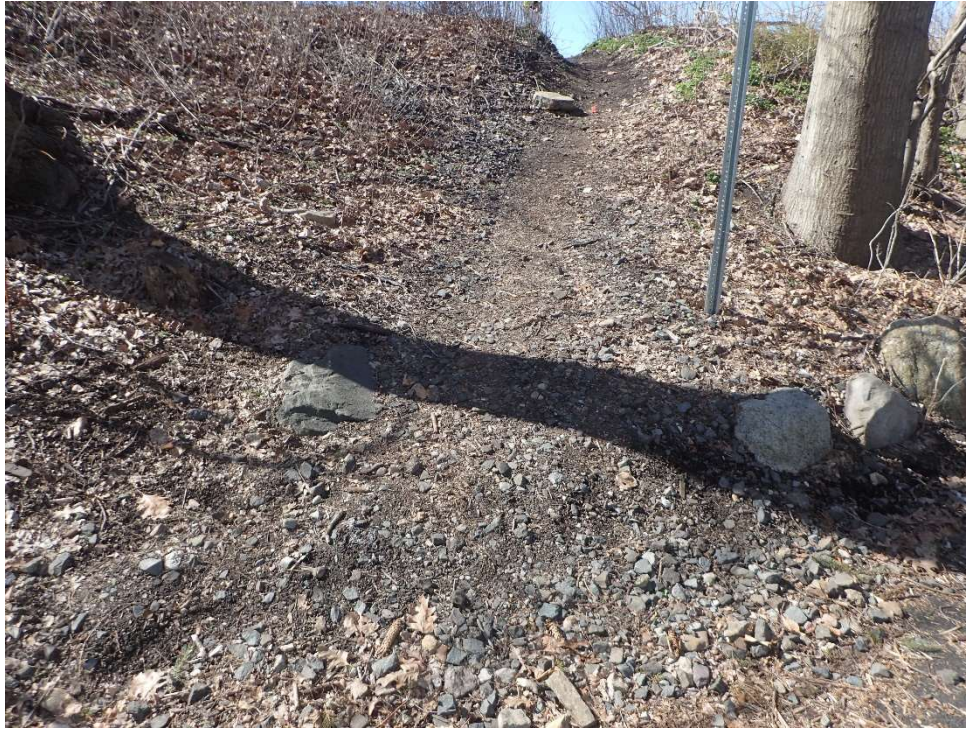
PHOTO 17: Foot trail at end of East Shore Road on downstream side, minor erosion looking southwest.

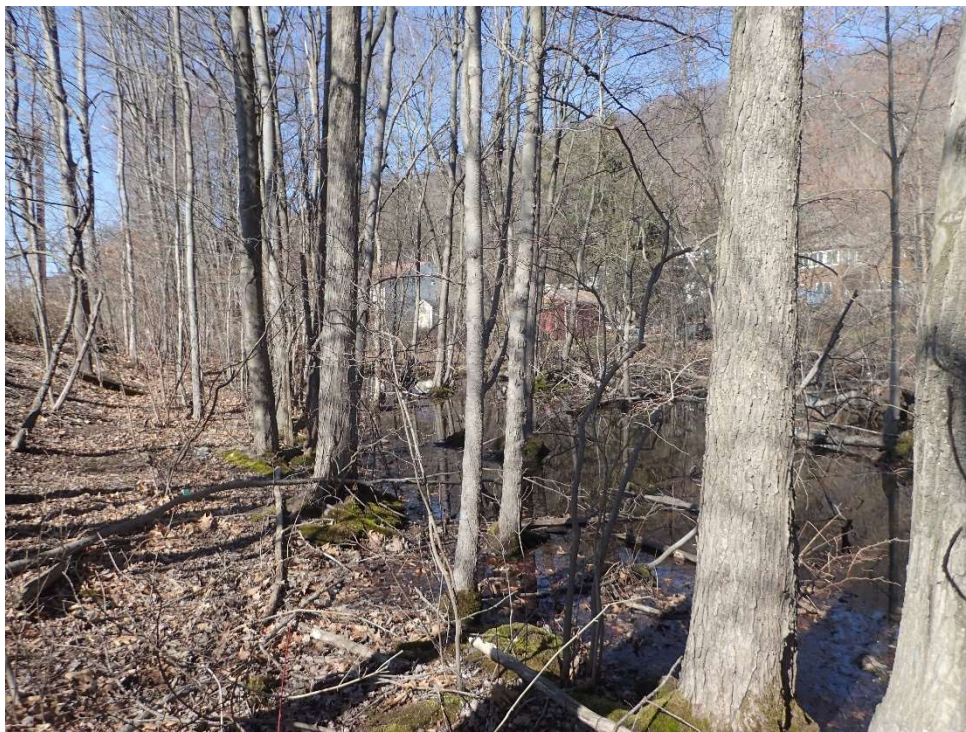
PHOTO 18: Ponding with meandering stream along dam embankment at downstream looking west.

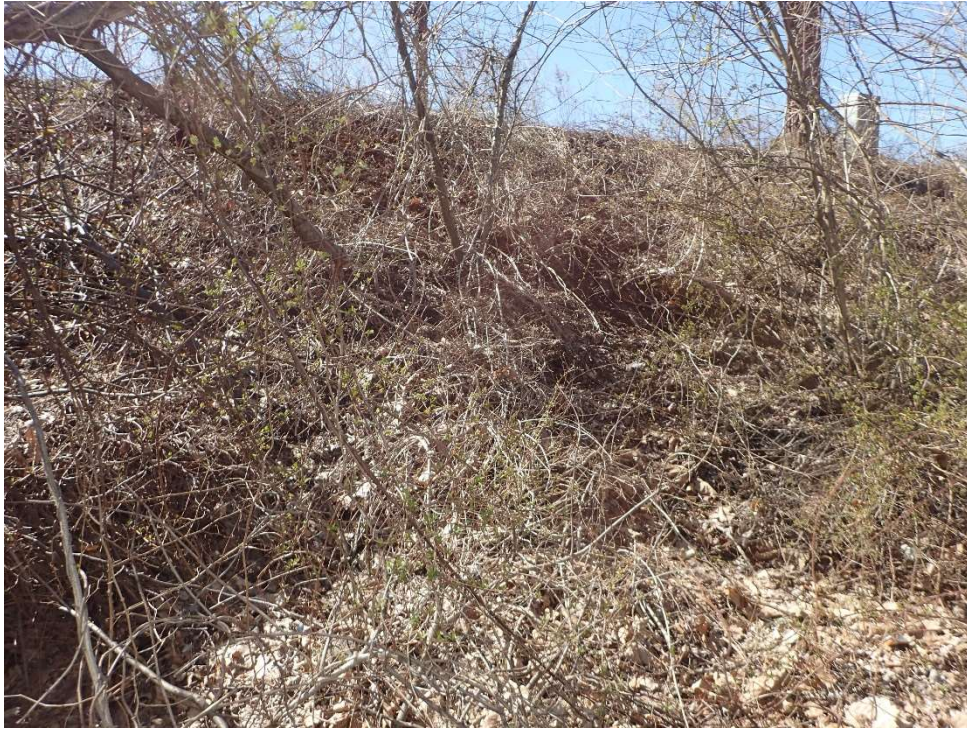
Sloughing, Subsidence or Depressions: **Each trail entry leads to erosion and an irregular slope (See Photos 9, 10 & 17). Did not notice previously noted slope undulation near the spillway. Some evidence of locally over-steepened slopes experiencing sloughing of topsoil mat (See Photo 19). One animal burrow found (See Photo 11).**

PHOTO 19: Previous topsoil sloughing covered with vegetation growth at downstream embankment looking south.

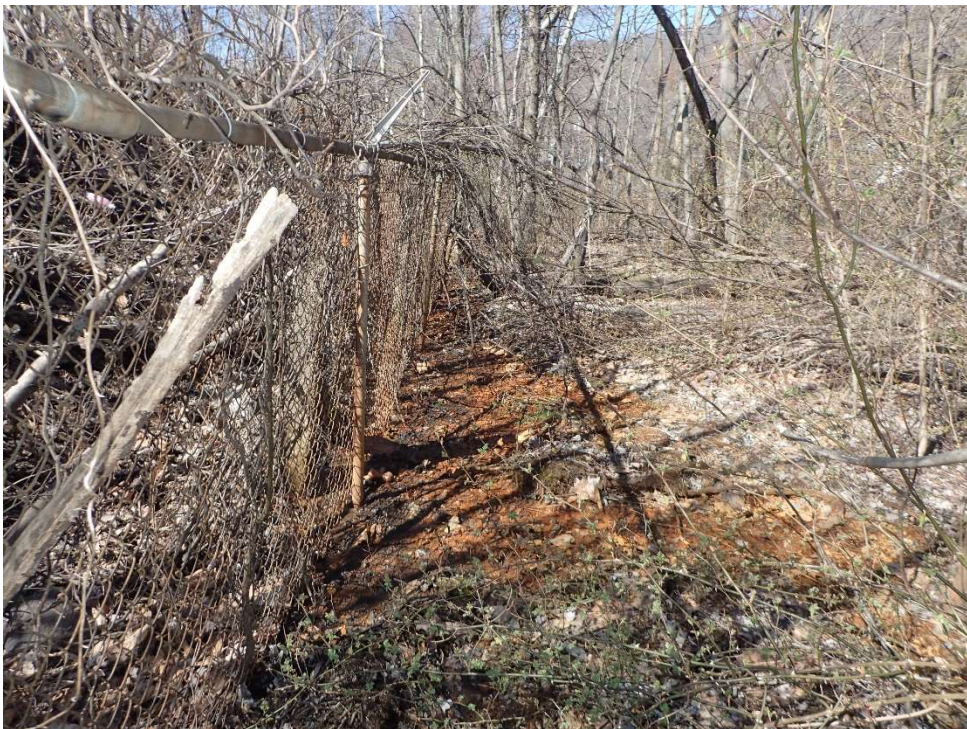
PHOTO 20: Boggy, wet area of possible seepage with rust stains at toe looking southwest.
