# Estling Lake Dam Spillway and Embankment Stability Evaluation

New Jersey Transit

February 2020

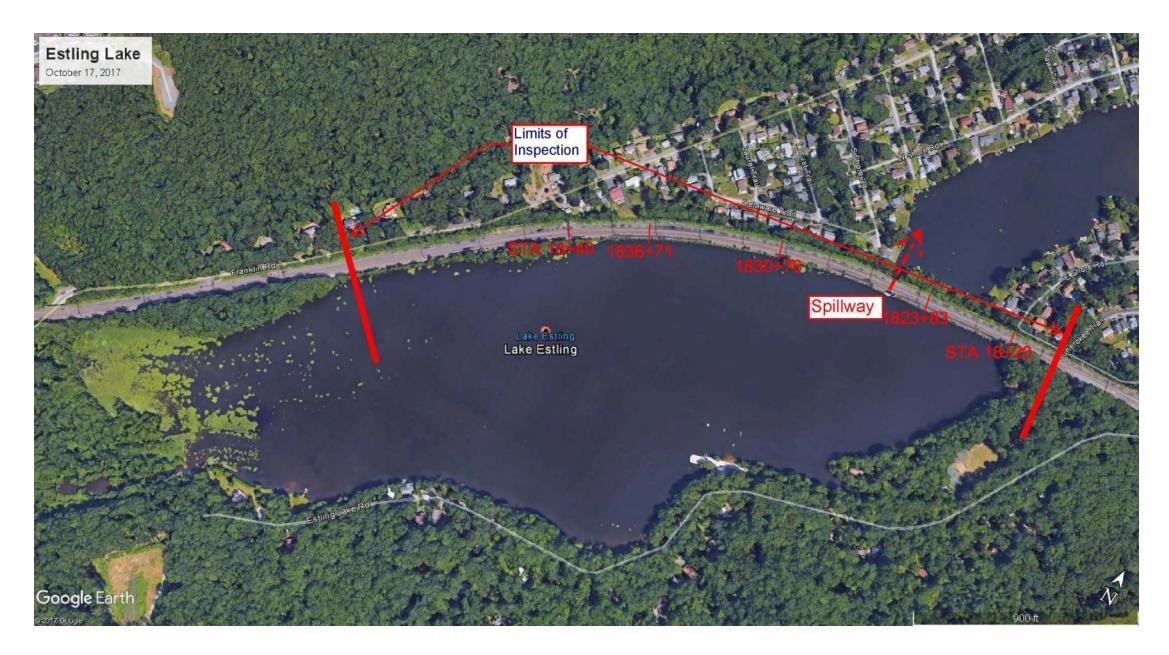
Figure G-2. Estling Lake Limits of Inspection from Formal Inspection Report

A Formal Inspection Report for Estling Lake Dam was submitted to NJDEP on September 5, 2018. The recommendations in this report require that NJ Transit submit the following additional documents to NJDEP:

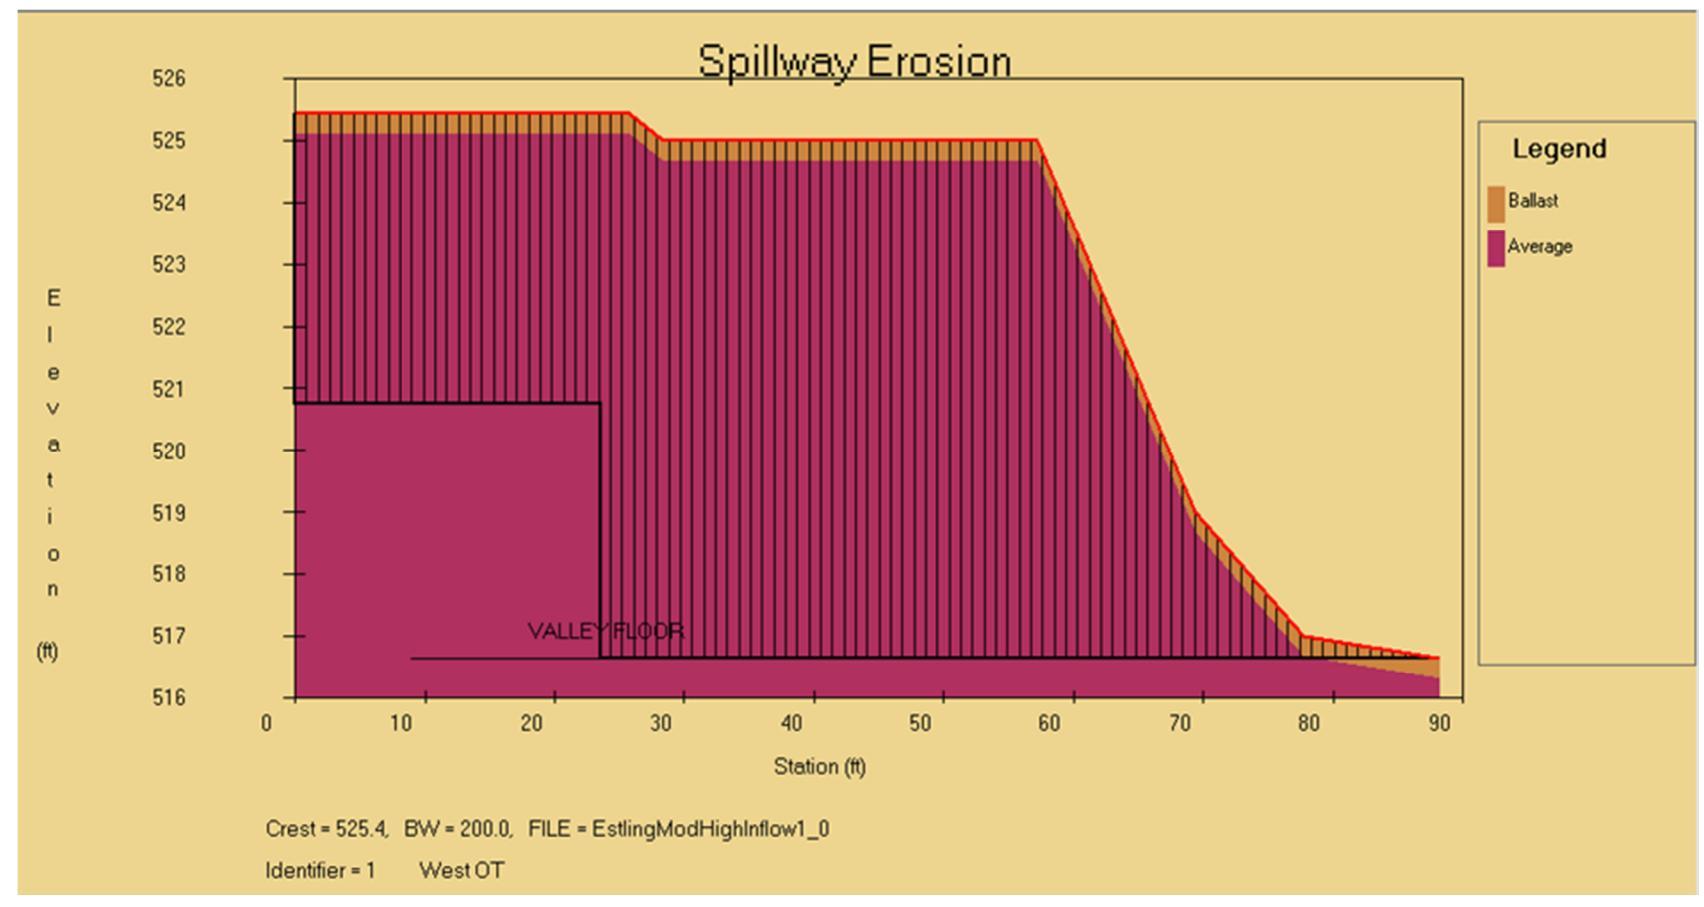
#### Figure E-1. STA 1836+71.40 Embankment Material Zones and Potential Erosion Results from WinDAM

The WinDAM analysis indicated that the railroad embankment downstream slope would experience significant erosion and head cutting, estimated to advance through the railroad embankment crest to the upstream embankment top of bank. This can be seen in **Figure E-1**, where the hatched areas represent the material eroded through the SDS overtopping event, and zero is the upstream embankment top of bank station. Due to the variability of the downstream slope, ranging from 3.5 to 49.7 percent, erosion progression would initiate with loss of riprap/ballast protection and partial head cutting ("nicking") at several locations, then progress to development of the headcut through the entire embankment. The model results show the overflow began at 1.5 hours, peaked at 41.3 hours, and flow duration was

53 hours. Head cutting began at multiple locations including the downstream embankment toe at 40.0 hours and advanced upstream to breach the crest at 43.3 hours.

The model computations terminate at the end of the discharge hydrograph duration, estimating a breach of the 57-foot-wide railroad crest through to the upstream top of embankment. The model estimates that the deepest head cutting will advance through more than half of the crest toward the upstream embankment, resulting in loss of half of the railroad crest and all of the downstream embankment removed down to the valley floor elevation of 516.63 feet NAVD88, with a head cut height of 8.8 feet. Headcut depth reached the valley floor elevation for the entire overflow length of the downstream embankment and a portion of the crest.

A limitation of the WinDAM model is that it simulates an inflow hydrograph through the reservoir storage. The 2019 HydroCAD outflow hydrograph (SWM, 2019) for the overtopping of the railroad embankment was provided and utilized as the inflow hydrograph to WinDAM. The starting water surface elevation was set to the minimum railroad embankment crest elevation, used as the spillway crest elevation, so there would be minimal routing storage resulting in this embankment section within the WinDAM model for areas of the dam higher than the spillway crest elevation. However, even with this conservative minimal storage causing WinDAM peak outflow to be slightly smaller than the peak outflow from HydroCAD, the WinDAM model showed that the railroad embankment will have significant erosion during the overtopping of the SDS. An additional scenario was simulated where the WinDAM model to the HydroCAD model results, to estimate the full erosion potential of the peak outflow during the SDS, which are the results reported and shown in **Figure E-1**.

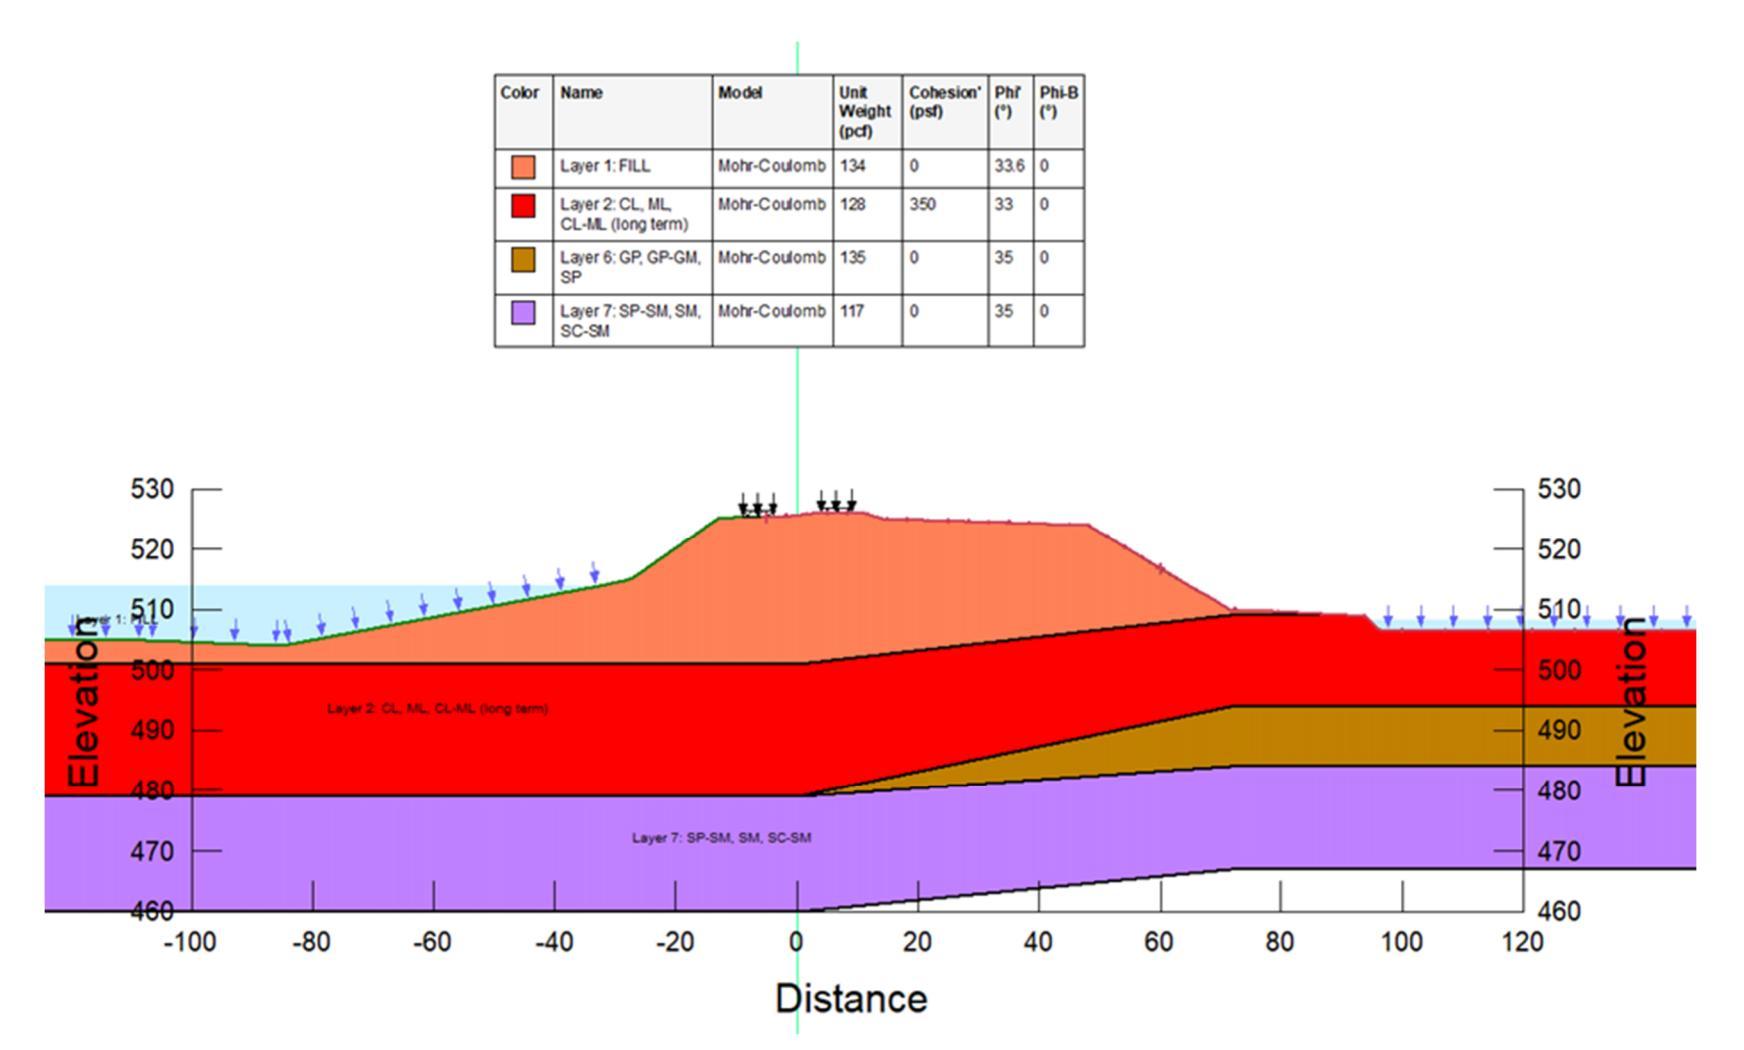
Figure S-1. Embankment Geometry and Material Zones - STA 1823+83.40

Results for STA 1823+83.4 do not meet criteria for the loading conditions specified, including the Normal Pool, Pseudostatic (i.e. seismic loading), which has a factor of safety less than 1.0 – a predicted failure condition where loading forces exceed the resistance the downstream embankment materials generate. HDR utilized a design MCE of 0.16g as defined by USGS for a 2475 year return event in the analyses. A Probabilistic Seismic Hazard Analysis (PHSA) of the site may be utilized to further define the MCE. Results for STA 1830+76.69 all meet criteria. Results for STA 1836+76.40 meet all criteria for loading conditions focused on the downstream slope; however, some of the results for the upstream slope are below the criteria.

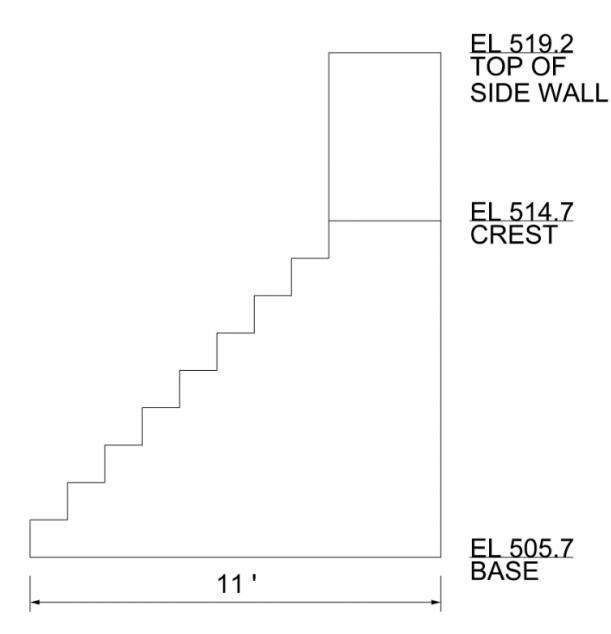
Figure SS-1. Masonry Dam Cross Section

Following the guidance in the Engineering Manuals, a global stability analysis was performed including overturning and sliding. The arch shape was ignored and the dam was analyzed as a gravity dam using the cross section of the dam (**Figure SS-1**). This is a conservative assumption as the geometric properties of an arch shape allowed the loads to be transferred to adjacent abutments embedded within the embankment rather than having the loads being resisted by only the soil interaction at the base. EM 1110-2-2201 Arch Dam Design states that all arch dam design shall be completed using a finite element analysis. Considering the scope of this task and using engineering judgment, this conservative approach was taken by treating the section as a gravity dam. The dam's cross section closely follows the design principals of gravity dams which most likely was the intent of the original designers. It is understandable the design intent was to incorporate an arch shape into the gravity dam layout.

Loa	Load Case Resultant Location Criteria				Res. Loc.	PASS	FAIL
SU	Usual	Middle 3rd	3.67	7.33	4.9	PASS	PASS
SUN	Unusual	Middle Half	2.75	8.25	5.0	PASS	PASS
SE1	Extreme	Within Base	0	11	4.9	PASS	PASS
SE2	Extreme	Within Base	0	11	12.1	PASS	FAIL

Loa	Load Case Req. FOS		FOS	PASS/FAIL
SU	Usual	2	1.8	FAIL
SUN	Unusual	1.7	2.6	PASS
SE1	Extreme	1.33	1.4	PASS
SE2	Extreme	1.33	0.6	FAIL

**Table SS-3** shows that the structure passes in sliding for two load cases and fails for two. Examining the two load cases that fail, it shows that for SU – Usual load case, a required FOS of 2 is required and the structure has a FOS of 1.8. This means the existing structure does not meet the standard design guidelines states within the Engineering Manuals, but the evaluation does not predict structural failure. For the SE1 – Extreme load case, the evaluation predicts that the structure fails with an FOS of 0.6.
